RELATIVE PERFORMANCE COMPARISON BETWEEN BASELINE LABYRINTH AND DUAL-BRUSH
COMPRESSOR DISCHARGE SEALS IN A T-700 ENGINE TEST
32225

Robert C. Hendricks NASA Lewis Research Center Cleveland, Ohio

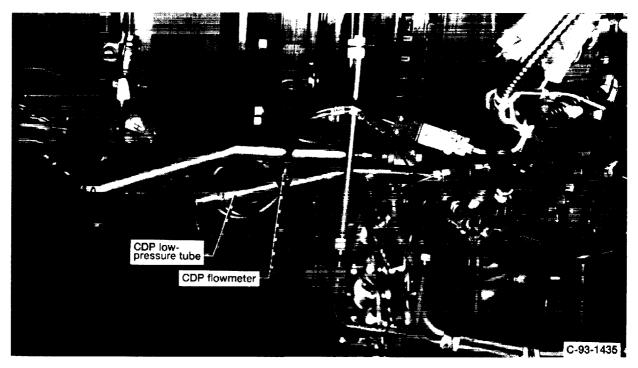
Figure 1.—Schematic of engine airflow and location of flowmeter.

The power stream airflow through the compressor and the secondary airflow leakage past the compressor discharge seal are illustrated in Fig. 1. The compressor discharge seal package and associated drain tube are located immediately downstream of the impeller and labeled CDS. The drain tube was opened after a series of runs and swabbed for debris.

(a) Airflow schematic.

(b) Location of CDP flowmeter.

During the test series the drain pipe (Fig. 1) was swabbed for debris. When these samples were in turn investigated with a scanning electron microscope (SEM), nickel, chromium, and tungsten lines were observed along with other unexplainable peaks of salts (e.g., Fig. 12). The nickel, chromium, and tungsten lines characterize bristle materials and some possible coating wear. The debris was fine and difficult to locate and isolate within the tube. Other metal sources and rubbing surfaces could have also produced such debris, but we attributed it to bristle wear.

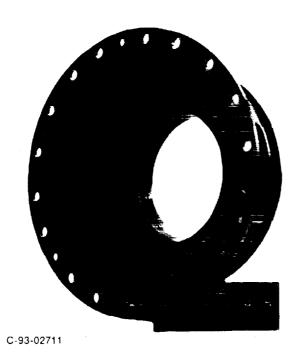
Figure 7.—Dual-brush compressor discharge seal system after testing.

Pretest and post-test photographs of the dual brush and its installation in the seal system are shown as a series in Fig. 7. Figure 8 depicts the dual brush prior to testing. Figure 7(a) shows the upstream view of the instrumented housing; four thermocouples are attached to the side plates with upstream and downstream pressure taps. Figure 7(b) shows a direct view from the downstream side, and Fig. 7(c) is an isometric view showing the "shiny" nature of the bristle interface. Actual brush seal dimensions, rub runner coating, and installation of instrumentation are proprietary.

(a) Upstream view.

(b) Downstream view.

(c) Isometric view.
